Jackson Street Sewer Detailed Investigation Timeline Description

Jackson Street Sewer Figures

North Yard – Bulkhead Area Figures

North Yard Figures

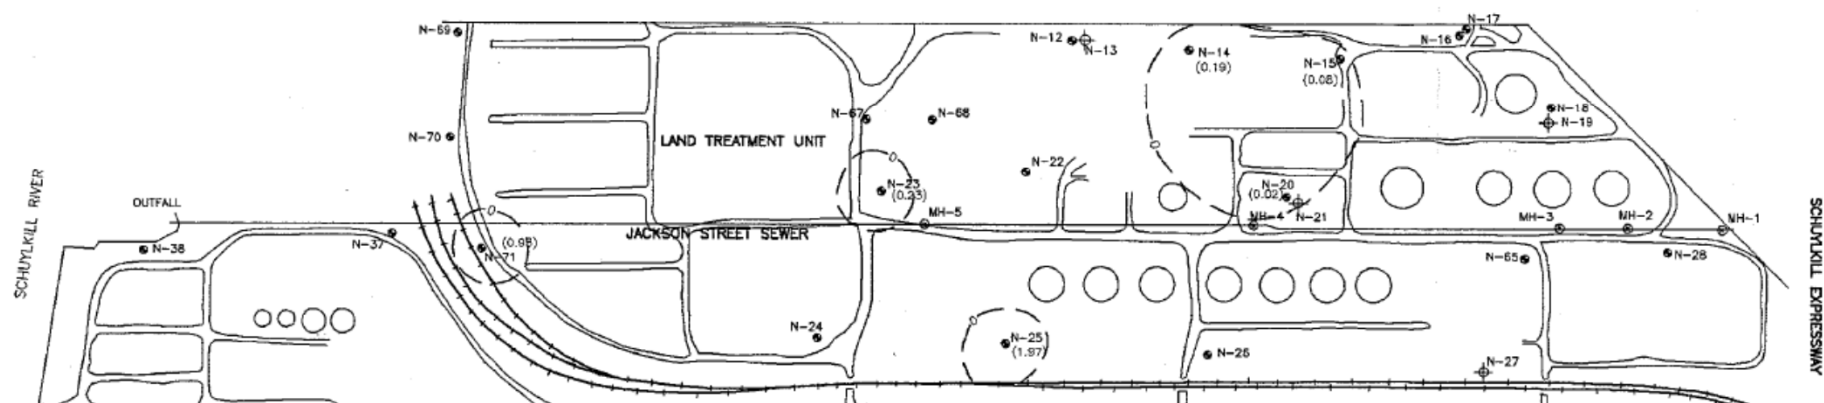
APPARENT NAPL THICKNESS
DECEMBER 1992 - GAUGING DATA
JACKSON STREET SEWER
SUN COMPANY, INC. (R & M)
PHILADELPHIA REFINERY
PHILADELPHIA, PENNSYLVANIA

OBSERVATIONS

4 Plumes – N-71, N-23, N-25 and (N-14,N-15,N-20)

All but N-25 are less than 1 foot thick

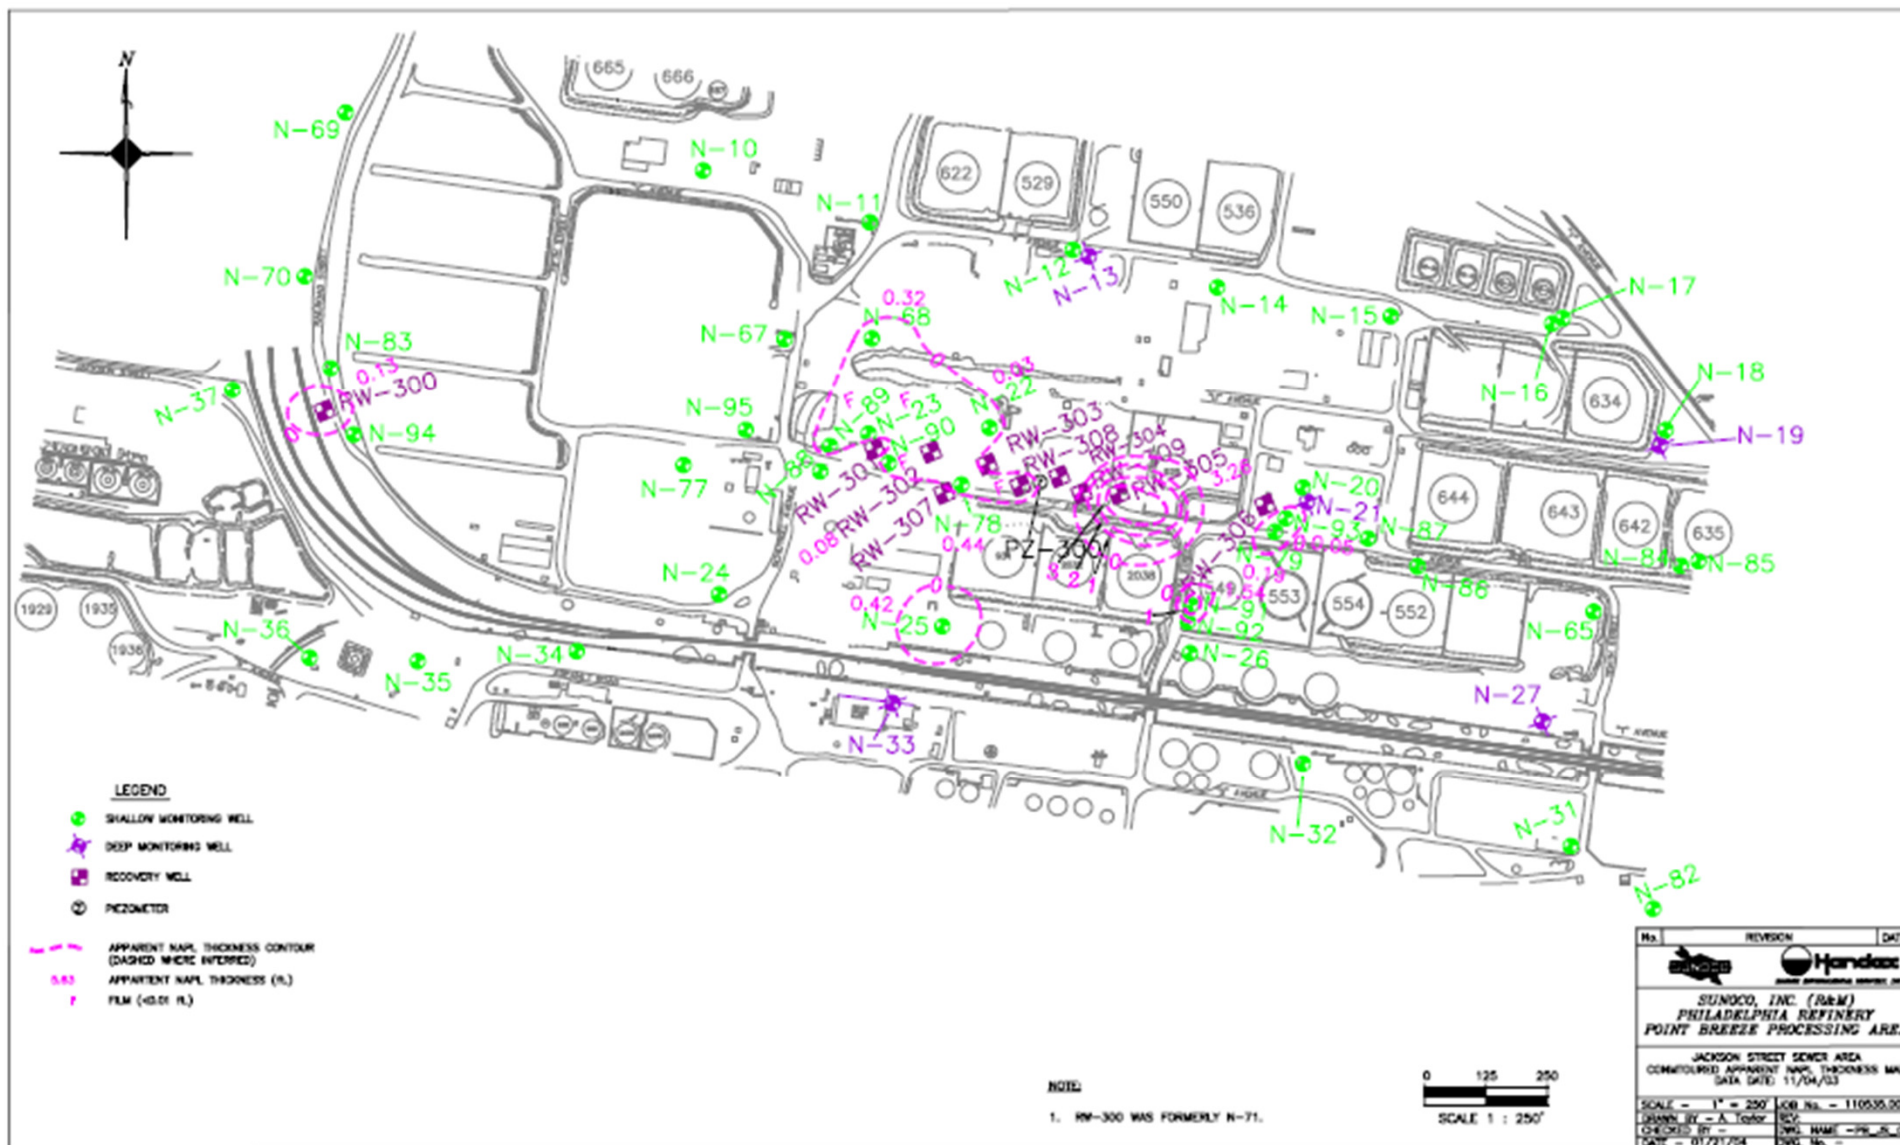
Point Breeze 4th
Quarter 2003
Report (pg. 43)

OBSERVATIONS

N-71 now RW-300 – Plume thickness decreased

N-23 – Plume size increased to N-68,N-89,RW-302,N-78,RW-308, and N-22 (thickness less than .5 ft)

N-14,N-15,N-20 – Plume is gone

N-25 – Plume thickness decreased to less than .5 ft

New Plume – Around RW-305 and RW-309 more than 3 ft thick

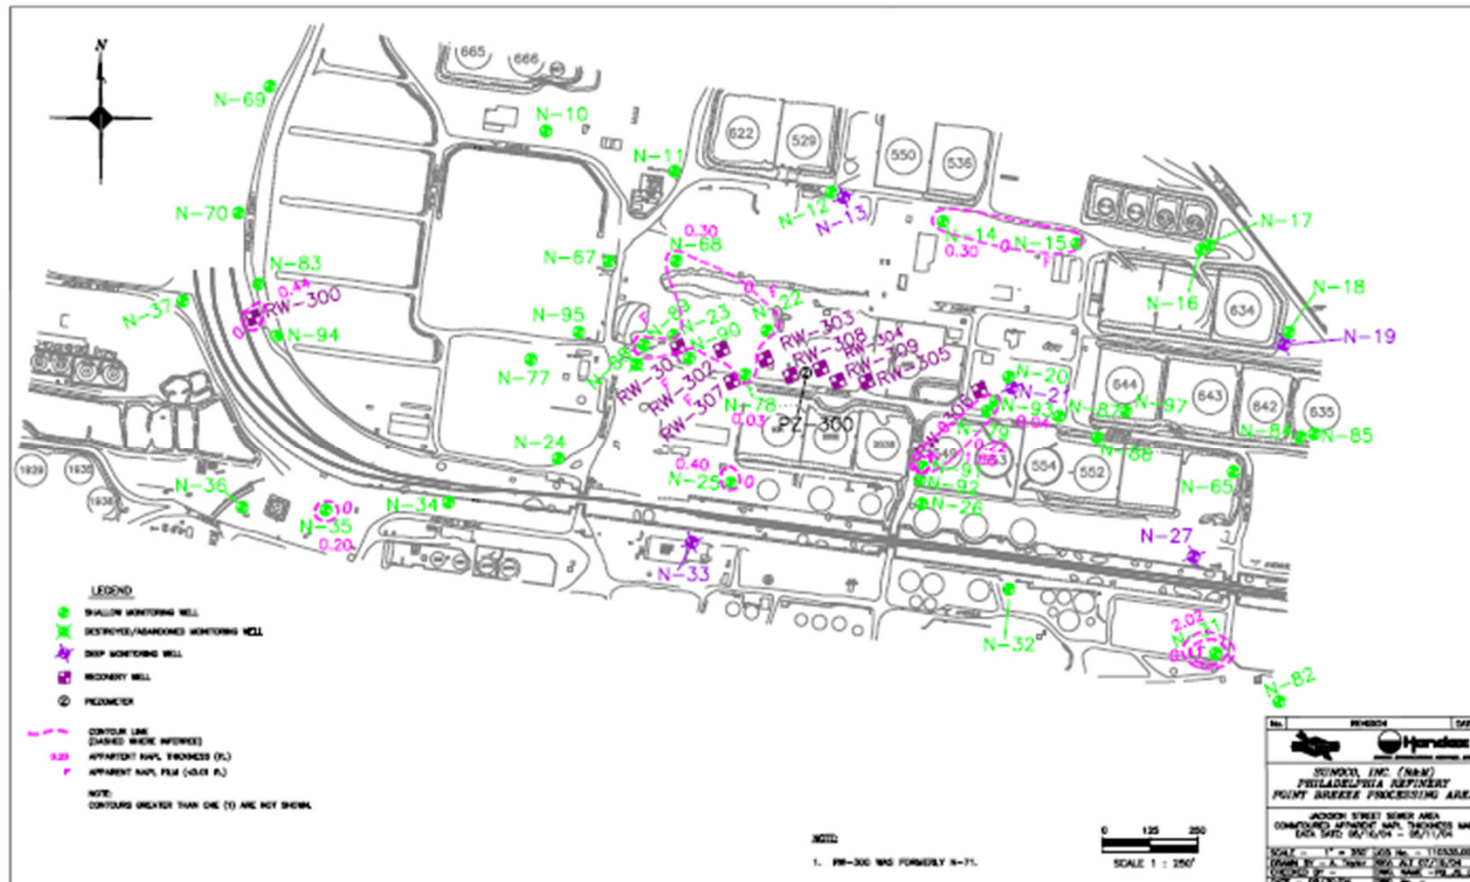
OBSERVATIONS

RW-300 – Plume thickness increased

N-23 – Plume size changed to N-68,N-89,RW-302,RW-301,N-78, and N-22 (thickness less than .5 ft)

N-14,N-15,N-20 – Plume is back around N-14 and N-15 (less than .5 ft)

N-25 – Plume thickness decreased slightly

Plume around RW-305 and RW-309 is gone

New Plume around N-91, N-79, and N-93 (more than a foot thick around N-91)

New Plume around N-35 (less than .5ft thick)

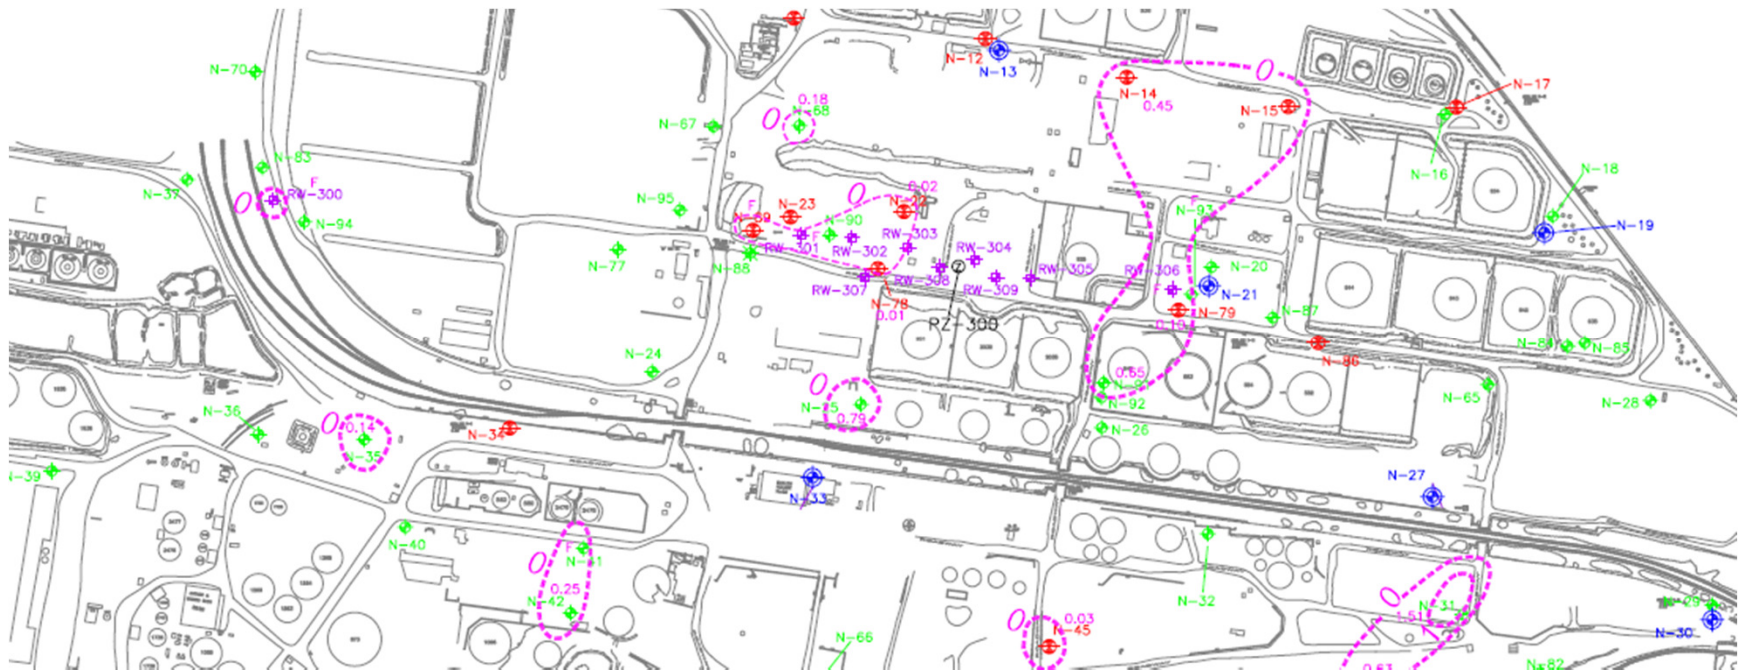
Point Breeze 4th
Quarter 2004
Report (pg. 257)

OBSERVATIONS

RW-300 – Plume thickness decreased to a film

N-23 no longer in the plume – Plume size changed to N-89,N-90,RW-302,RW-301,N-78, and N-22
(thickness increased to less than 1 ft)

New Plume at N-68 – separated from the N-23 plume

2 Plumes combined to include N-91, N-79, RW-306, N-93, N-14 and N-15 (less than 1 ft thick)

N-25 – Plume thickness increased

Plume around N-35 thickness decreased slightly

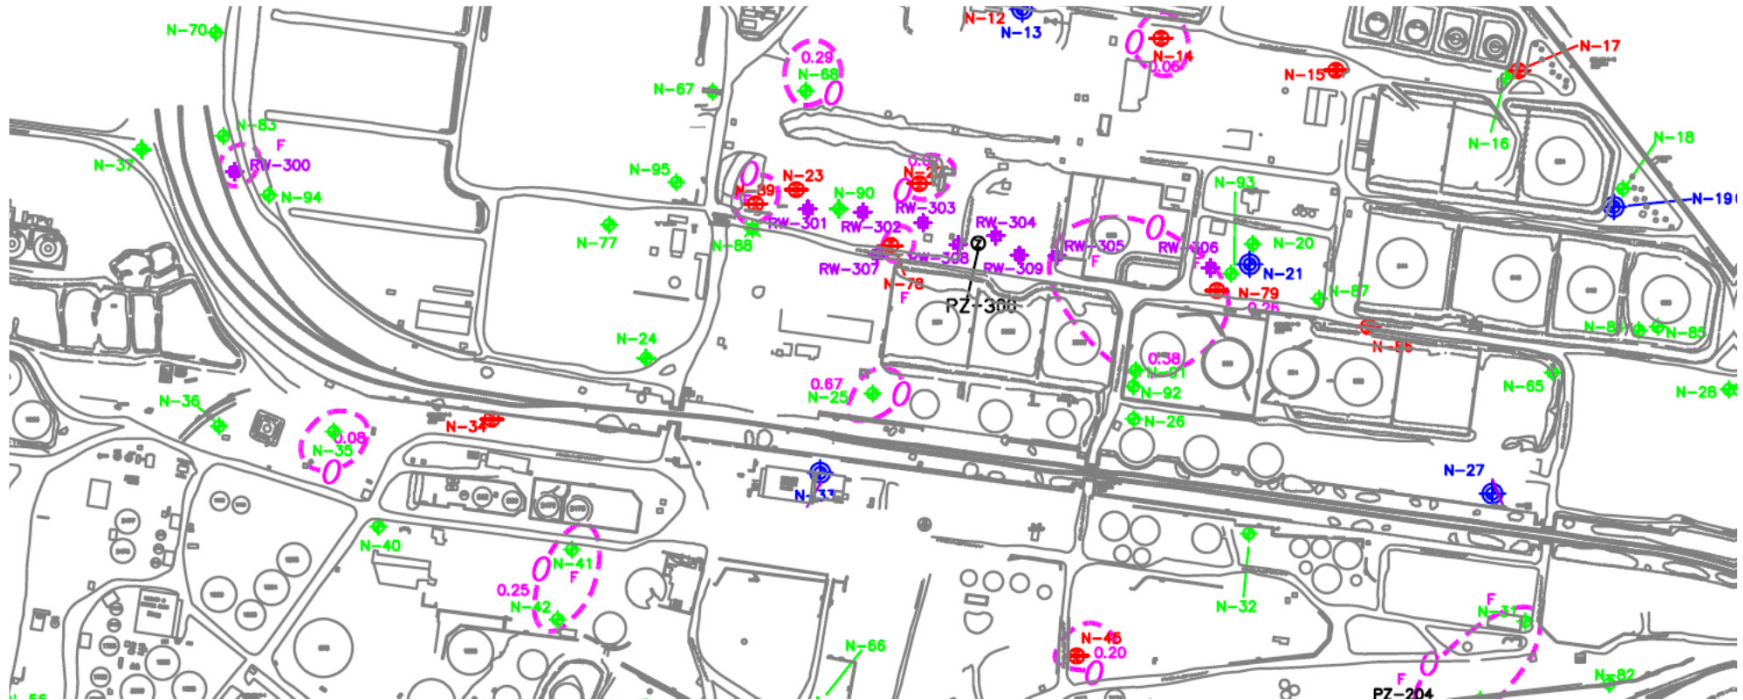
Point Breeze 2nd
Quarter 2005
Report (pg. 83)

OBSERVATIONS

RW-300 – Plume thickness remained same

Plume size decreased to multiple separate plumes - N-89, N-78, and N-22 are all separate plumes (thickness decreased to film in N-89 and N-78, thickness less than .5 ft in N-22)

Plume at N-68 – increased in thickness slightly

Plume N-91, N-79, RW-306, N-93, N-14 and N-15 changed – Separate plume N-14 and Plume RW-305, RW-306, N-91 and N-79 thicknesses less than .5 ft

N-25 – Plume thickness decreased slightly

Plume around N-35 thickness decreased slightly

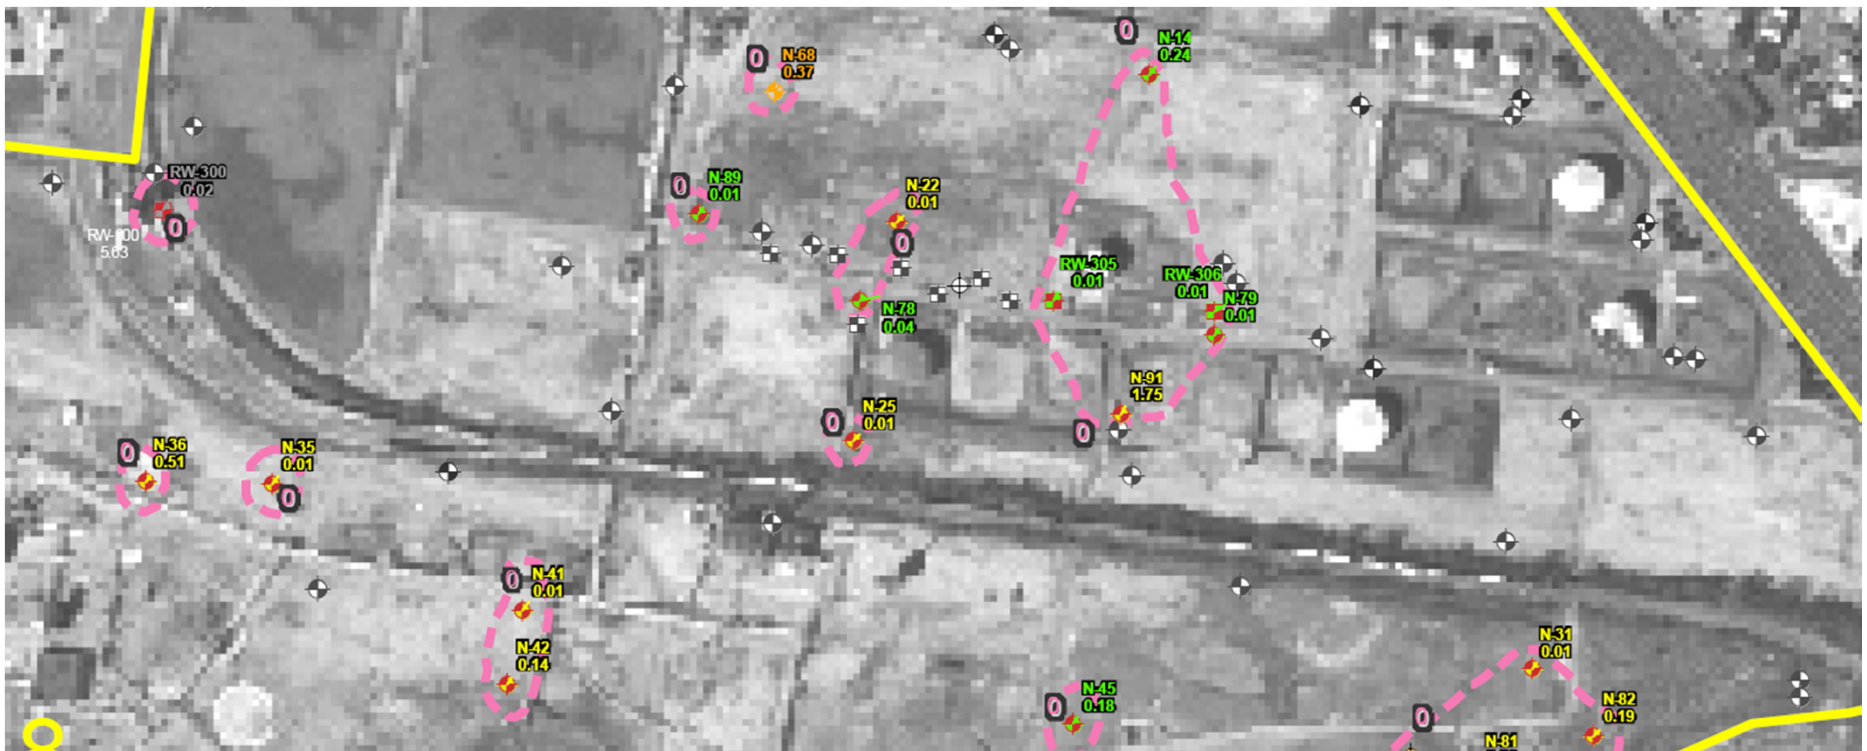
Point Breeze 4th
Quarter 2005
Report (pg. 50)

OBSERVATIONS

RW-300 – Plume thickness increased slightly

Plume size changed to plumes - N-89, and N-78 and N-22 as a combined plume

Plume at N-68 – increased in thickness slightly

Separate plume N-14 is now combined with Plume RW-305, RW-306, N-91 and N-79

N-25 – Plume thickness decreased slightly

Plume around N-35 thickness decreased slightly

New Plume around N-36 thickness around .5 ft

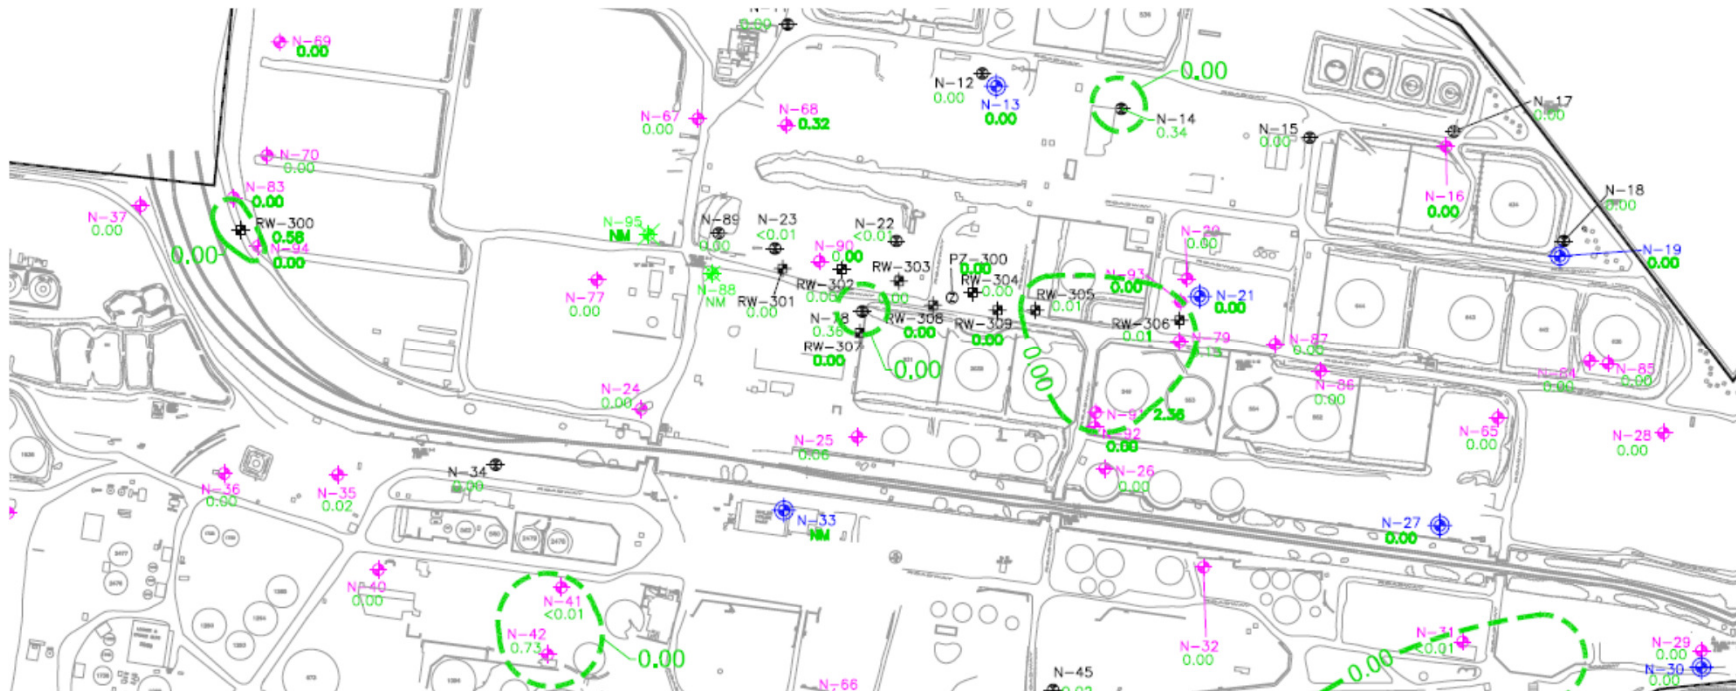
Point Breeze 2nd
Quarter 2006
Report (pg. 97)

OBSERVATIONS

RW-300 – Plume thickness increased slightly and now includes N-94 and N-83

Plume size changed to plumes - N-89 no longer plume, and N-78 and N-22 as separate plumes

Plume at N-68 – decreased in thickness slightly

Separate plume N-14 is now separated from Plume RW-305, RW-306, N-91 and N-79 (now plume includes N-93, and N-92)

N-25 – Plume thickness increased slightly

Plume around N-35 thickness increased slightly

Plume around N-36 is now gone

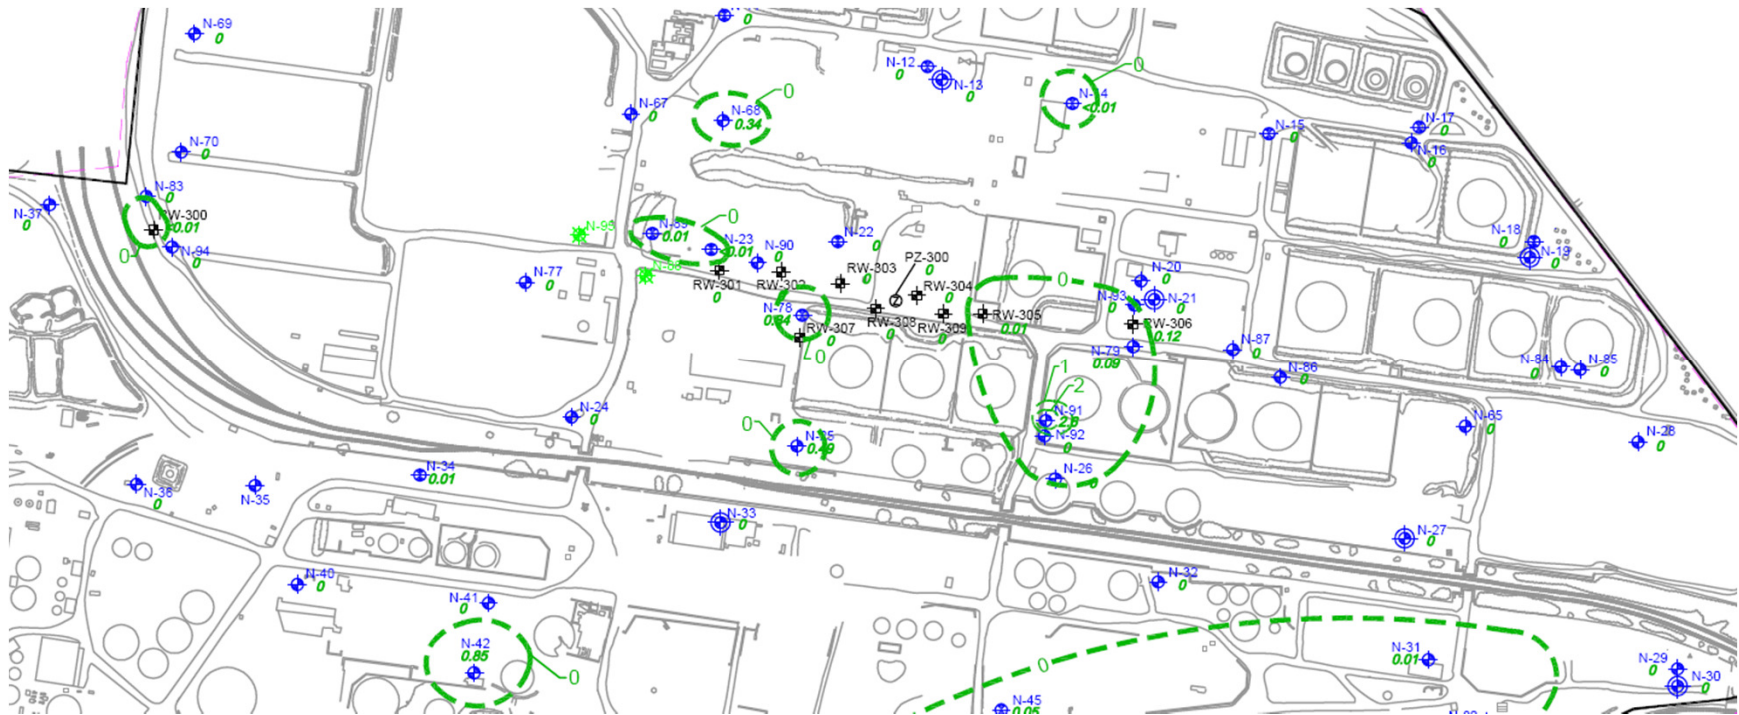
Point Breeze 4th
Quarter 2006
Report (pg. 28)

OBSERVATIONS

RW-300, N-94 and N-83– Plume thickness decreased slightly

N-89 plume returns and includes N-23

Plume N-78 thickness increased slightly

Plume N-22 is no longer present

Plume at N-68 – increased in thickness slightly

Plume N-14 thickness decreased slightly

Plume RW-305, RW-306, N-91, N-79, N-93, and N-92 now includes N-26 and has increased in thickness

N-25 – Plume thickness increased

Plume around N-35 no longer present

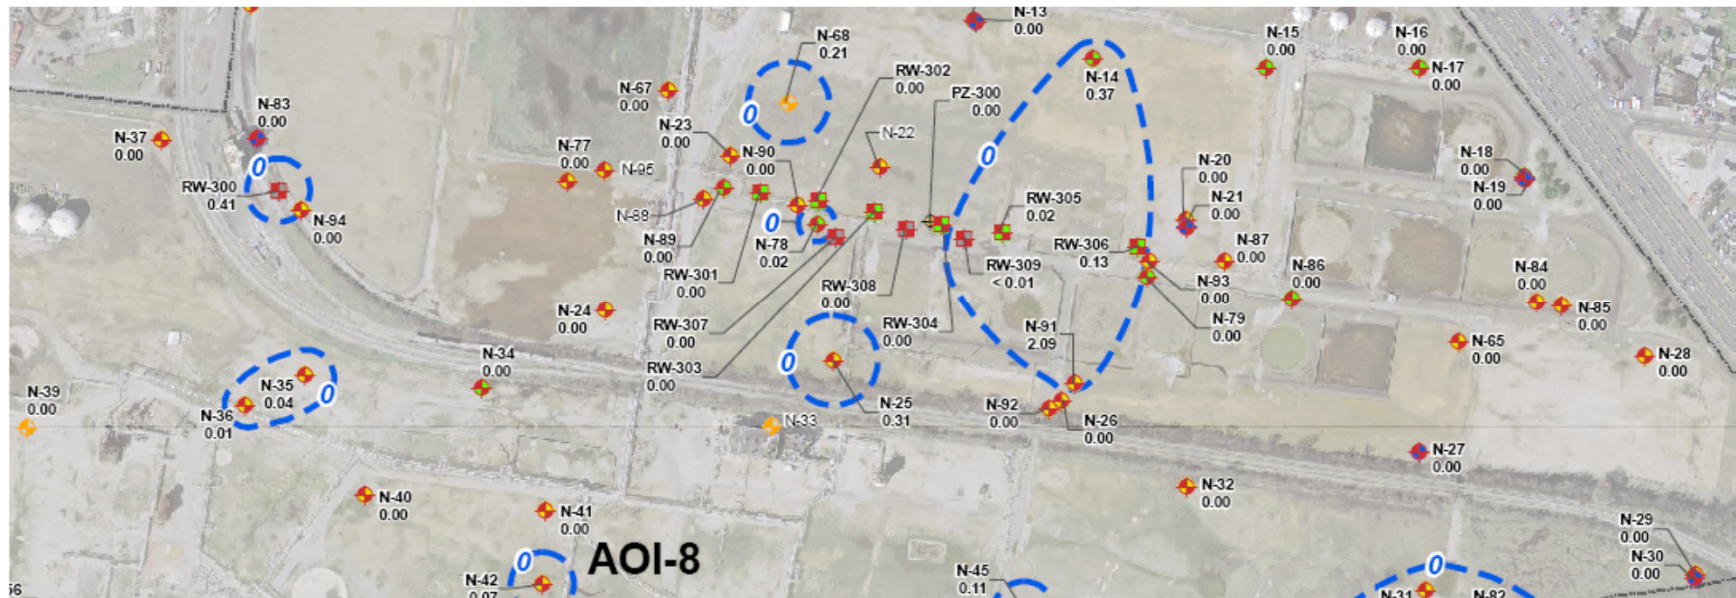
Point Breeze 4th
Quarter 2007
Report (pg. 35)

OBSERVATIONS

RW-300, N-94 and N-83– Plume thickness increased slightly but no longer includes N-83

N-89 plume no longer present

Plume N-78 thickness decreased slightly

Plume at N-68 – decreased in thickness slightly

Plume N-14 combined with Plume RW-305, RW-306, N-91, N-79, N-93 now includes RW-309 and no longer includes N-92 and N-26

N-25 – Plume thickness decreased

Plume around N-35 returns and includes N-36

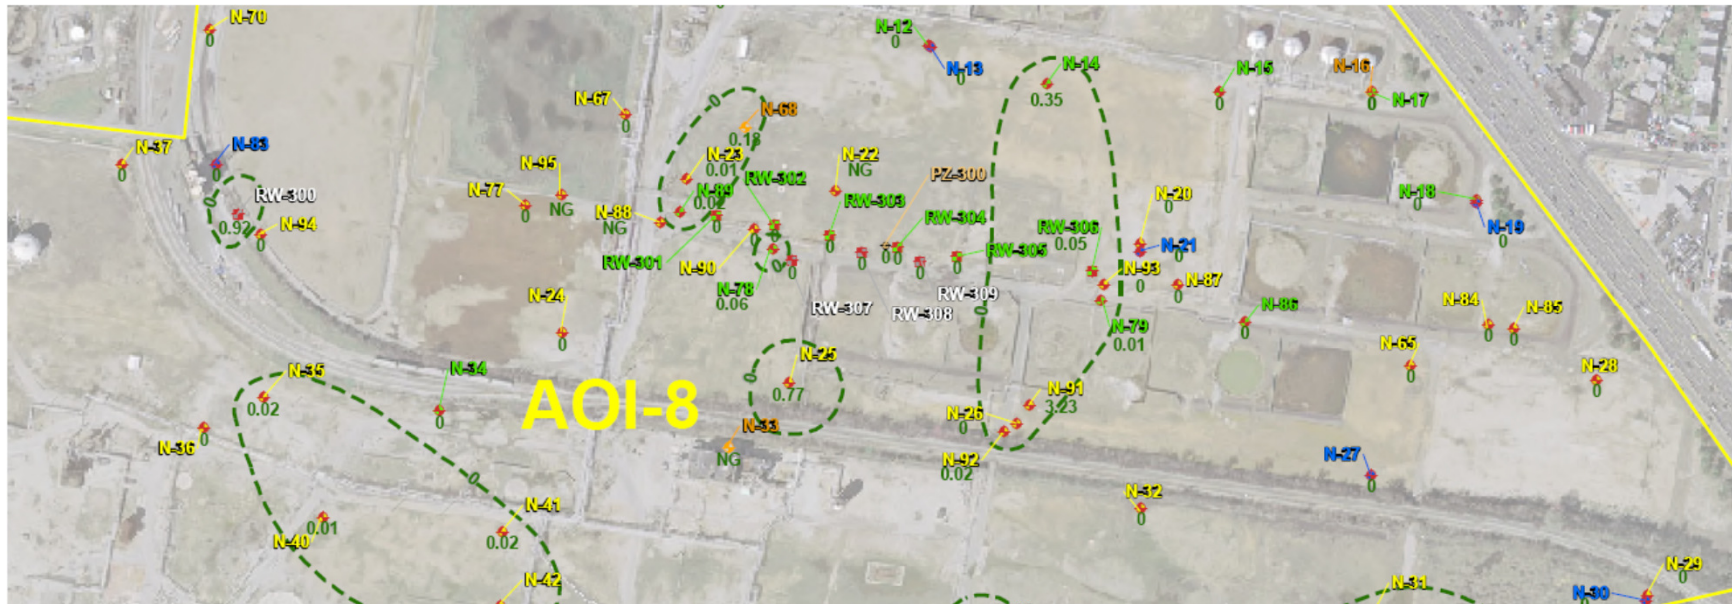
OBSERVATIONS

RW-300 and N-94– Plume thickness increased slightly but no longer includes N-94

N-89 plume returns and now includes N-23 and N-68

Plume N-78 thickness increased slightly

Plume N-14 combined with Plume RW-305, RW-306, N-91, N-79, N-93 now includes RW-309 and no longer includes N-92 and N-26

N-25 – Plume thickness decreased

Plume around N-35 and N-36 increases and now includes – N-35, N-40, N-45 and N-42

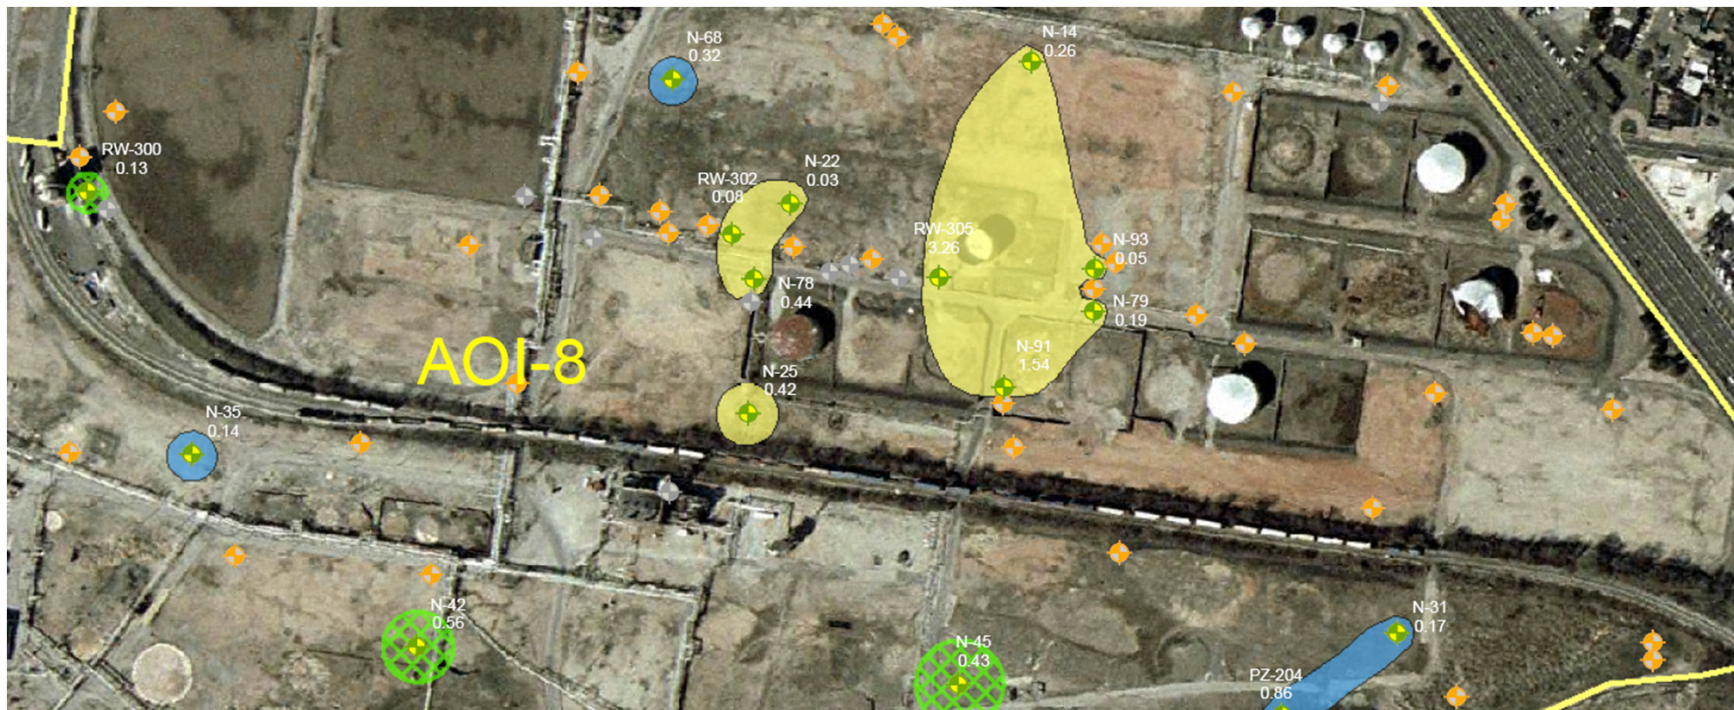
CCR - Figure 5
data collected
11/2003

OBSERVATIONS

RW-300 Plume thickness decreased slightly

N-89, N-23 and N-68 plume no longer present

Plume N-78 now includes RW-302 and N-22

Plume N-14, RW-305, RW-306, N-91, N-79, N-93 RW-309 no longer includes RW-306, or RW-309

Plume N-25 thickness decreased slightly

Plume around N-35, N-36, N-35, N-40, N-45 and N-42 changes to 2 small plumes – plume N-35 and plume N-42

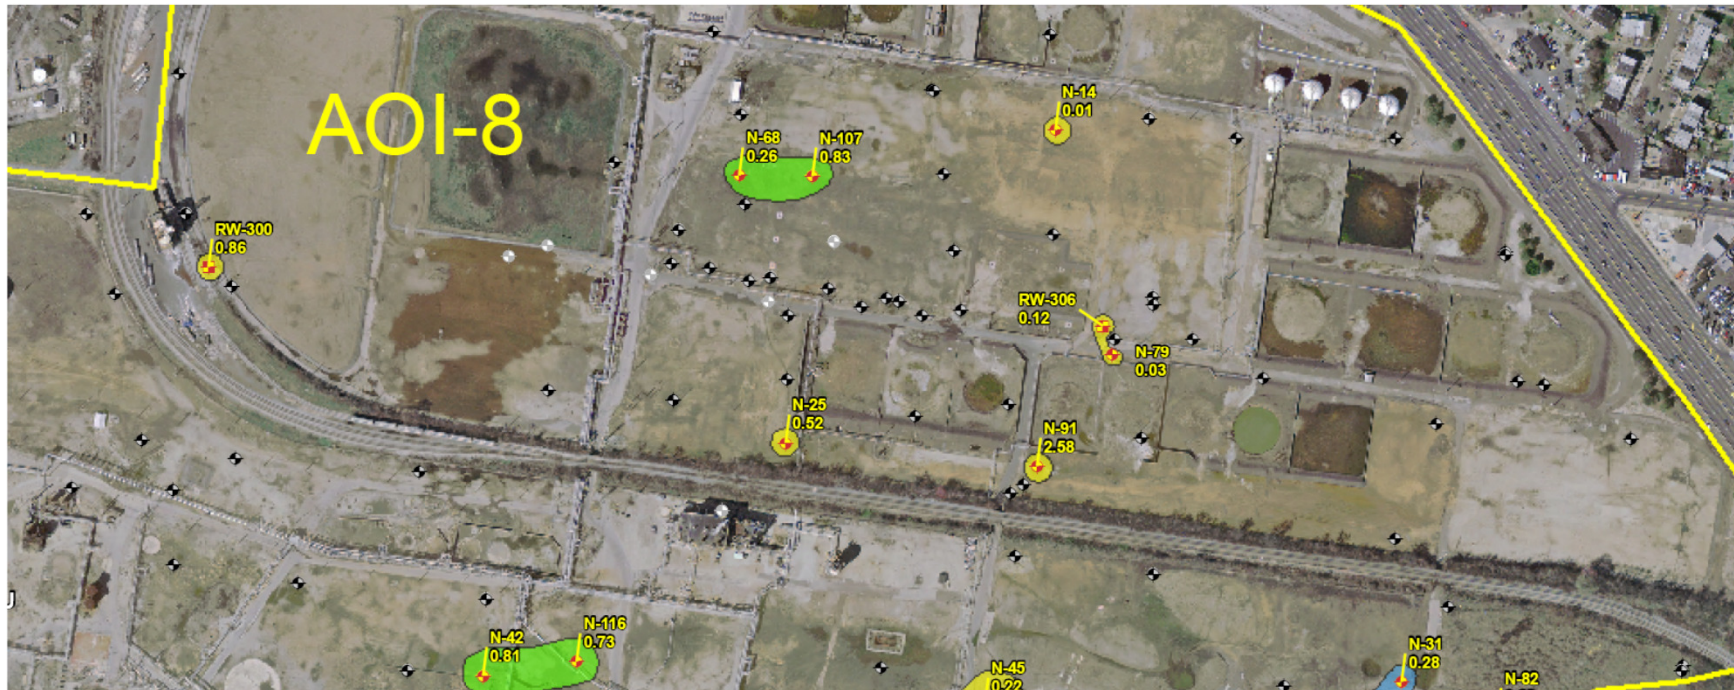
AOI 8 SCR - Figure 11

OBSERVATIONS

RW-300 Plume thickness increased slightly

N-68 plume returns and includes N-107

Plume N-78, RW-302 and N-22 no longer present

Plume N-14, RW-305, N-91, N-79, N-93 now broken into smaller plumes – Plume N-14, Plume N-91 and Plume N-79 and RW-306

Plume N-25 thickness increased slightly

Plume N-35 no longer present

Plume N-42 now includes N-116

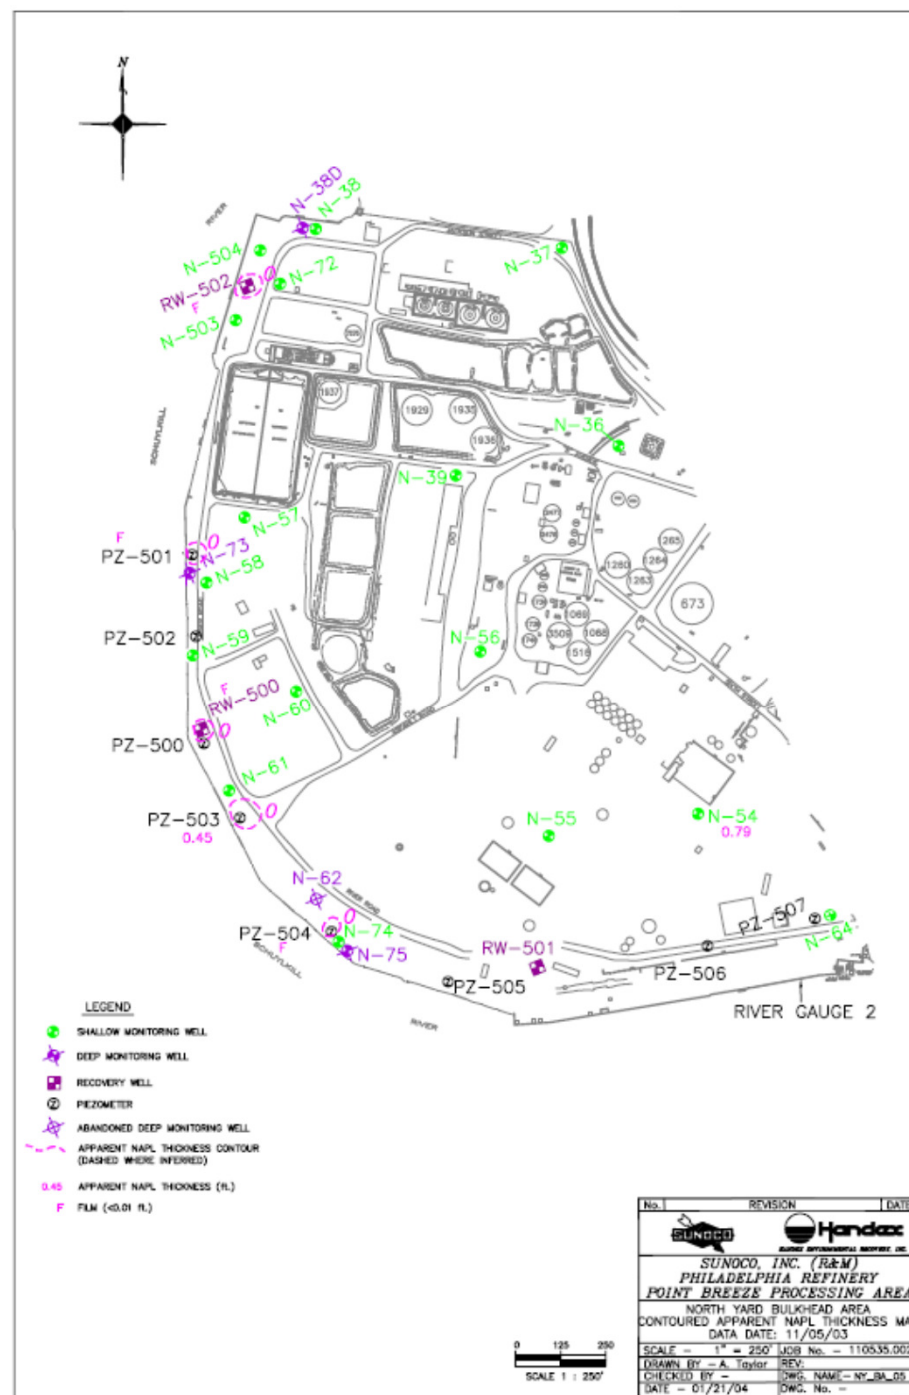
Point Breeze 4th
Quarter 2003
Report (pg. 97)

OBSERVATIONS

5 separate plumes present
with thicknesses under .5ft

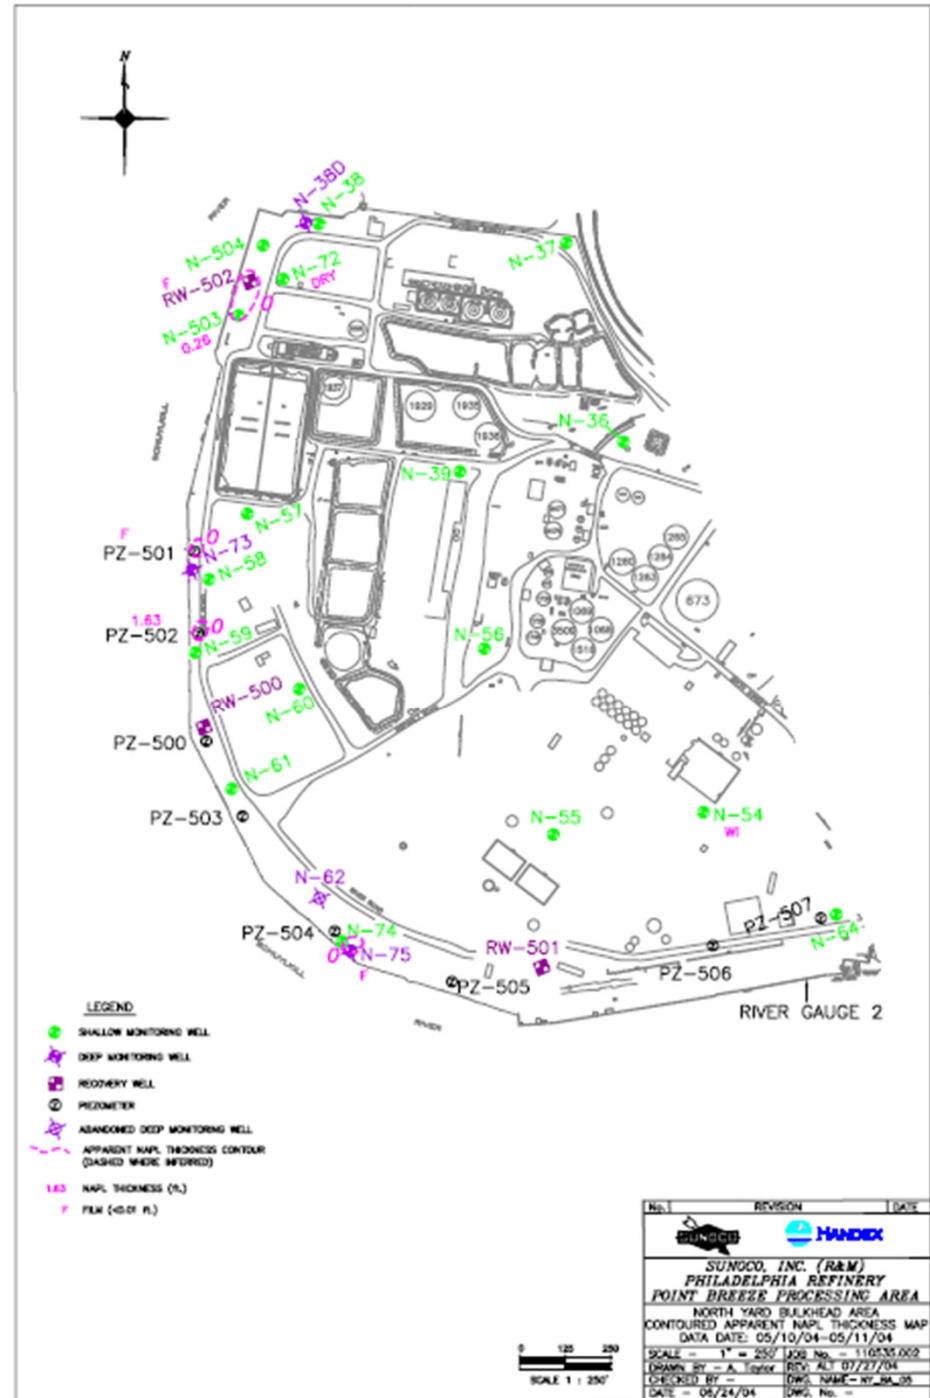
Point Breeze 2nd
Quarter 2004
Report (pg. 54)

OBSERVATIONS

Plume RW-502 now includes N-503

PZ-501 – no change

RW-500 – no plume present

PZ-503 – no plume present

PZ-504 – no longer in plume –
plume moved to N-75

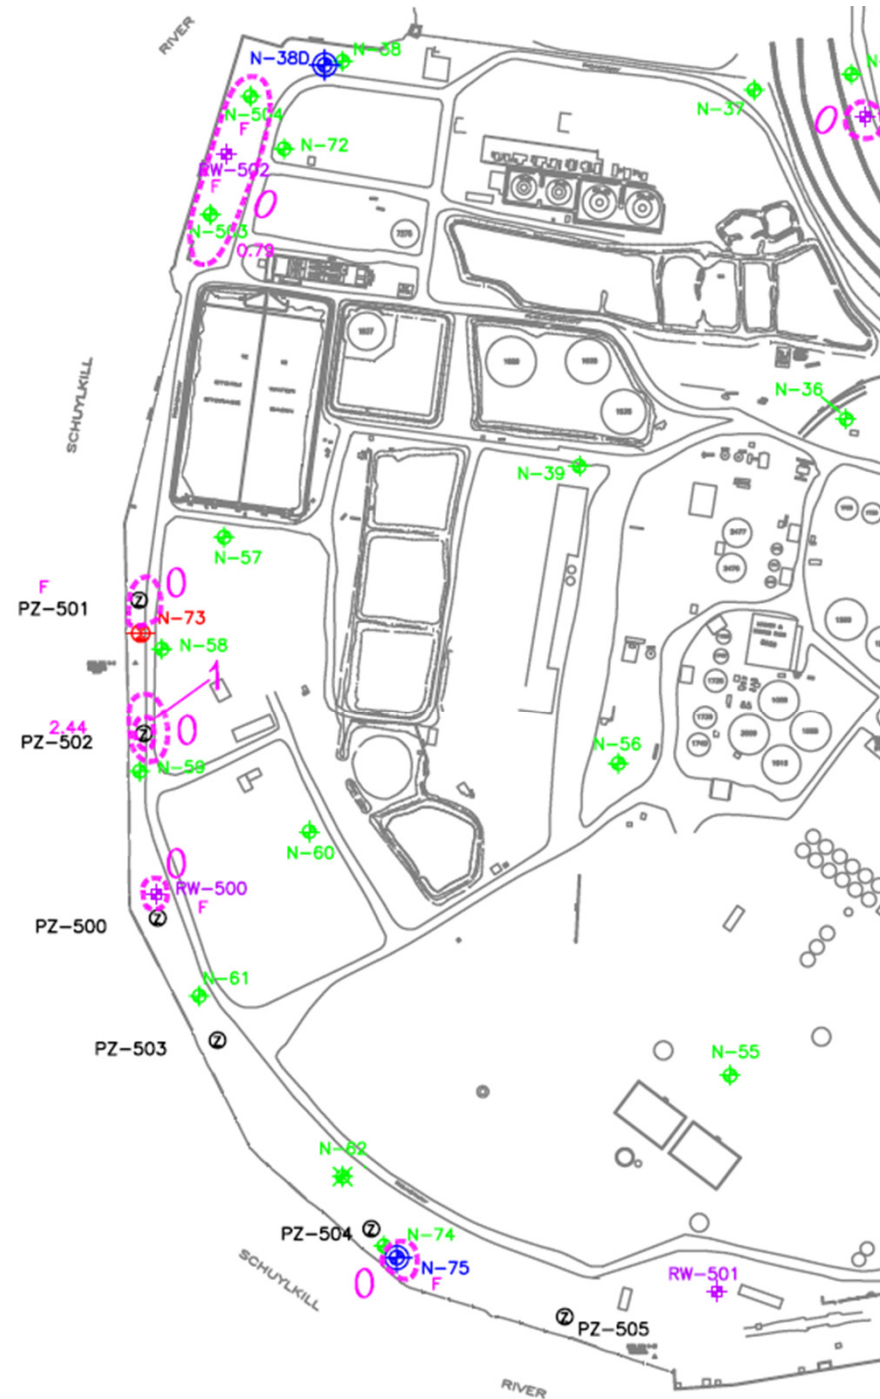
Point Breeze 4th
Quarter 2004
Report (pg. 257)

OBSERVATIONS

Plume RW-502 and N-503 now includes
N-504

PZ-501 – no change

New Plume PZ-502 – more than 2 ft thick

RW-500 –plume returns

PZ-503 – no plume present

Plume N-75 – no change

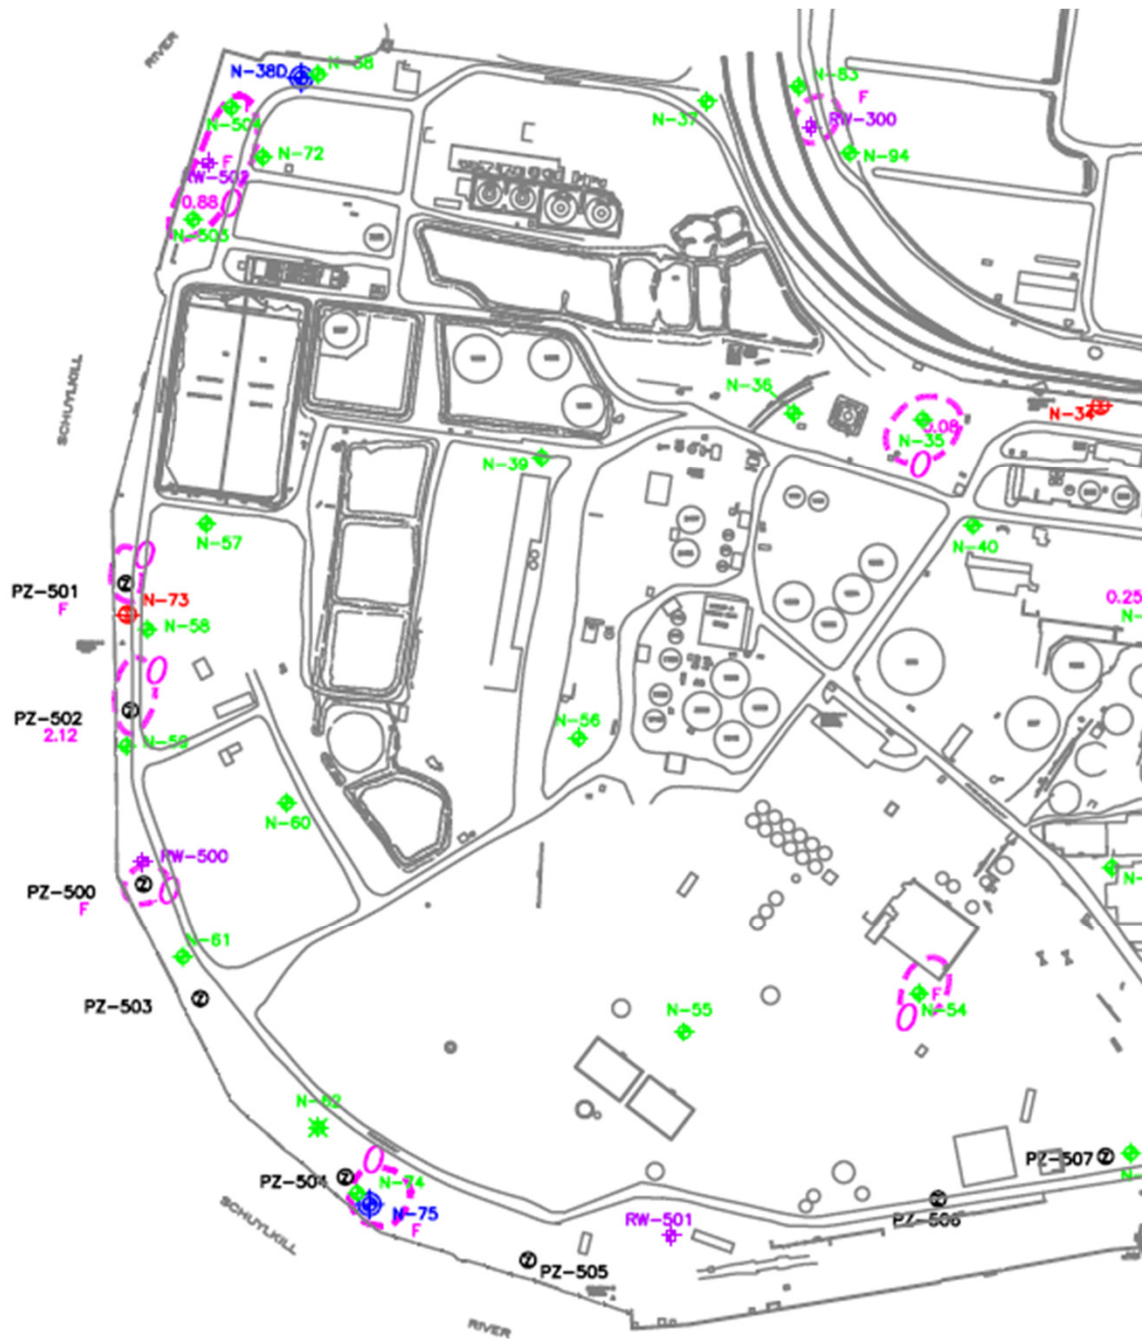
OBSERVATIONS

Plume RW-502, N-503 and N-504 –
thickness increased slightly

Plume PZ-501 – no change

Plume PZ-502 – still more than 2 ft thick

Plume RW-500 –plume moved to PZ-500

Plume N-75 – now includes N-74
